Investigation Report

East Flare Detonation

Date of Incident: 4/6/13

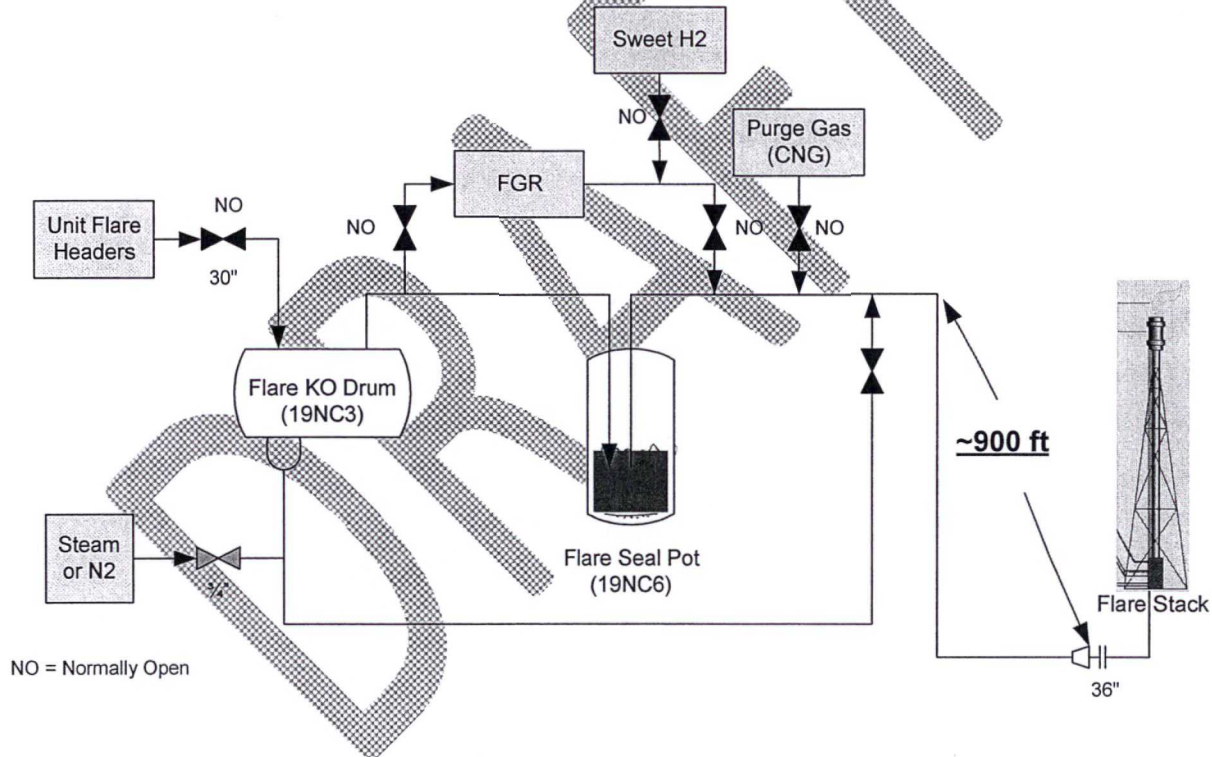
Figure 1. East Flare System Simplified Flow Diagram

East Flare Stack (19NF3) design varies from the North and South Flares in that it has an inline Molecular Seal with external drain piping and a Muffle Burner Tip. The Molecular Seal's purpose is to reduce the amount of purge gas flow required to prevent Oxygen intrusion in the system through the flare tip. The Muffle Burner Tip's purpose is to reduce the ambient noise during normal Flare Stack operation.

The vapor from the header first enters the KO Drum (19NC3), where any liquids drop out and are routed to slops tank 105. The gasses are routed to the Flare Gas Recovery (FGR) unit and downstream of the Seal Pot (19NC6). This Seal Pot provides enough back pressure to the system to force the gasses back to the FGR. Once past the seal pot, the vapor travels down the line, through the Molecular Seal and out of the Flare Stack (19NF3), where it is incinerated at the Muffle Burner Tip.
